ASBESTOS REGISTER / INCIDENT REPORT

Address of property:	Name of Competent person:
40 Asbestos Street Hazardville NSW	Neil Wallace, 0419 285443

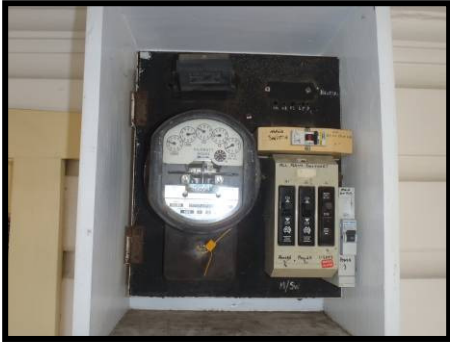
Date Identified	Type of ACM	Is it Friable or Non Friable?	Specific location(s)	Is this an accessible area	Condition	Recommendation	Control Priority	Reinspect	Photo No.
22/06/16	Bonded sheeting	Non Friable	The mounting board to the electrical meter box	Yes	Intact	N/A Refer to the Management Plan	Low	22/06/21	1
22/06/16	Fibro sheeting	Non Friable	The flat sheet fibro wall cladding to the front gable walls	Yes	Intact	N/A Refer to the Management Plan	Low	22/06/21	2 & 3
22/06/16	Fibro sheeting	Non Friable	The flat sheet fibro wall & ceiling linings to the first bathroom/WC room	Yes	Intact	N/A Refer to the Management Plan	Low	22/06/21	4
22/06/16	Fibro sheeting	Non Friable	The flat sheet fibro wall & ceiling linings to the locker area	Yes	Intact	N/A Refer to the Management Plan	Low	22/06/21	5

1. Mounting board

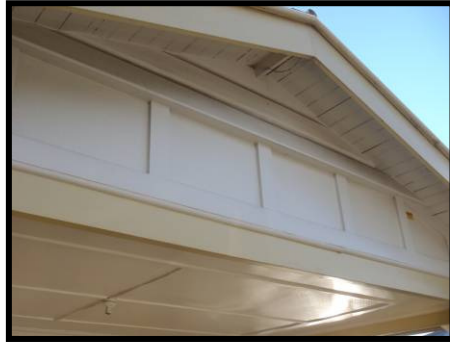
2. Cladding

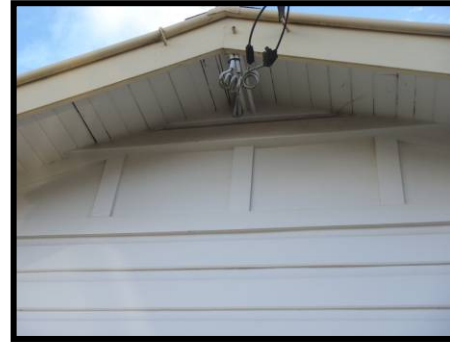
3. Cladding

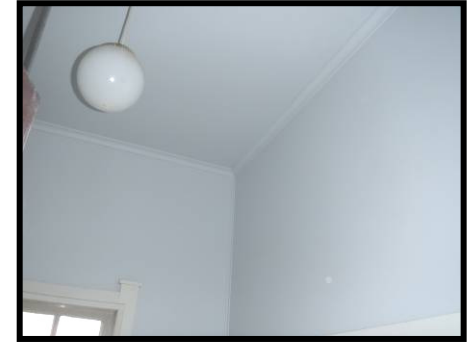
4. First bathroom

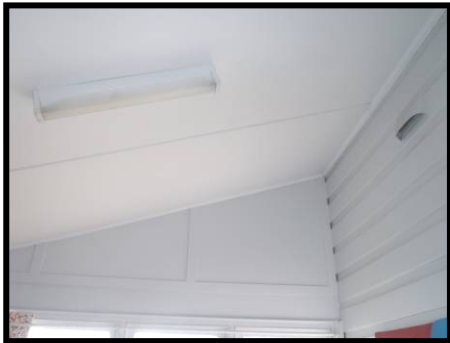
5. Locker area

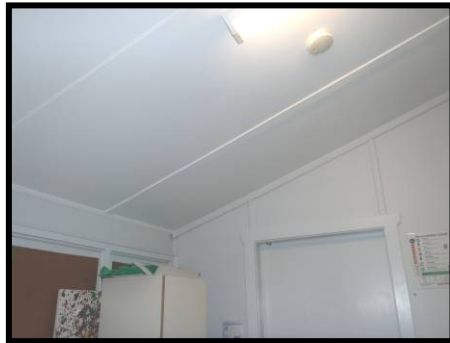
Date Identified	Type of ACM	Is it Friable or Non Friable?	Specific location(s)	Is this an accessible area	Condition	Recommendation	Control Priority	Reinspect	Photo No.
22/06/16	Fibro sheeting	Non Friable	The flat sheet fibro wall & ceiling linings to the change room	Yes	Intact	N/A Refer to the Management Plan	Low	22/06/21	6
22/06/16	Fibro sheeting	Non Friable	The flat sheet fibro wall & ceiling linings to the laundry	Yes	One wall sheet near the door is cracked	Short term encapsulate with sealant. Replacement is recommended Refer to the Management Plan	Moderate	22/06/17	7 & 8
22/06/16	Fibro sheeting	Non Friable	Fibro packing between piers & floor framing	No	Intact	N/A Refer to the Management Plan	Low	22/06/21	11 & 12

6. Change room

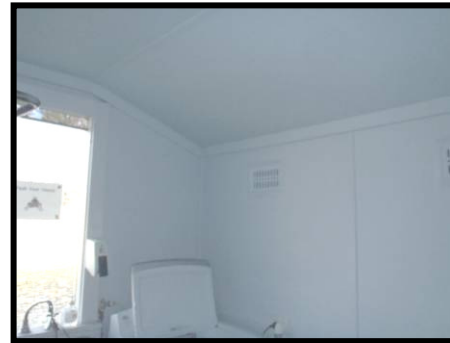
7. Laundry

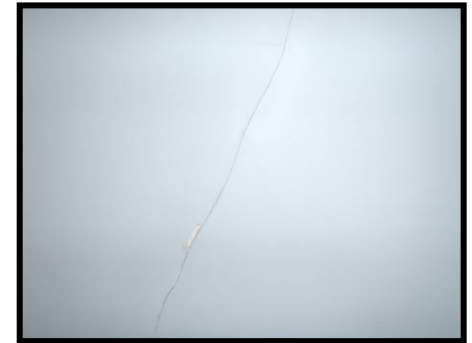
8. Broken sheet

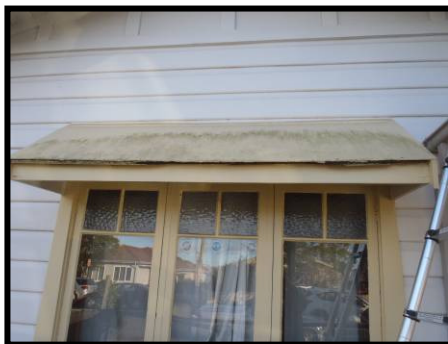
Date Identified	Type of ACM	Is it Friable or Non Friable?	Specific location(s)	Is this an accessible area	Condition	Recommendation	Control Priority	Reinspect	Photo No.
22/06/16	Fibro sheeting	Non Friable	Lining to the hood/awning.	Yes	Intact	<p>Treat as if the material is ACM until the composition can be confirmed.</p> <p>Refer to the Management Plan</p> <p>Probability Unlikely</p>	Low	22/06/17	9
22/06/16	Fibro sheeting	Non Friable	Any materials of a fibro nature that are concealed, over-sheeted, or are buried in the ground.	No	Unknown	<p>Treat as if the materials are ACM until the composition can be confirmed.</p> <p>Refer to the Management Plan</p> <p>Probability Likely if found</p>	Low	N/A	N/A

9. Hood/awning
